23.08.2010

**SERVICE BULLETIN SB FSG2T-1.05**

**TYPE DESIGNATION** FSG 2T VHF/AM Airband Transceiver – Part number F10350

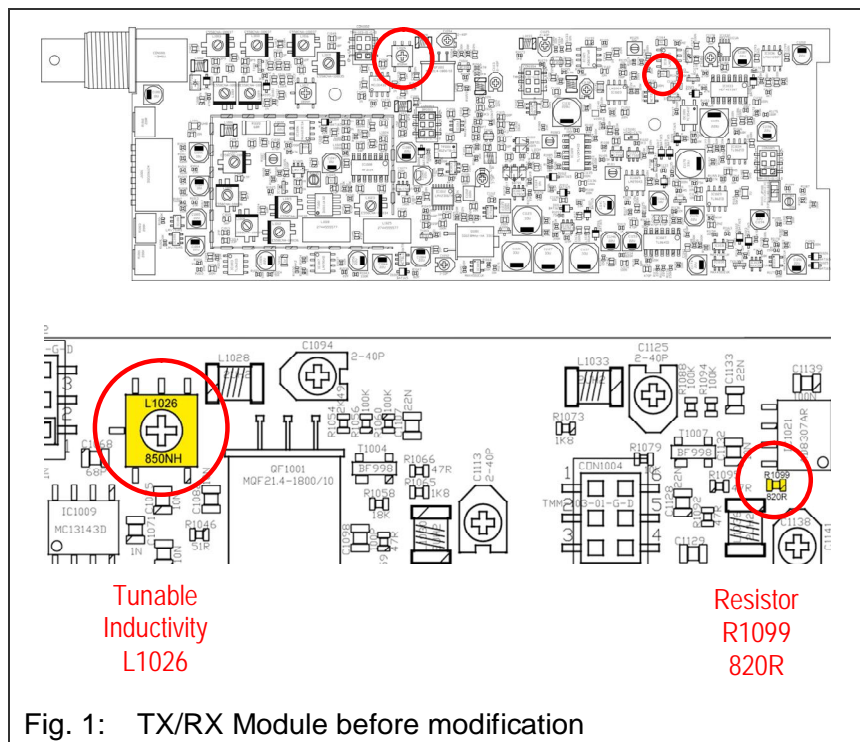
Fig. 1: TX/RX Module before modification

**DESCRIPTION** Verify reliable communication in the vicinity of external RF transmitters, which could disturb active communication channels. Improvement against external RF signal, exceeding the maximum limits, can be achieved by modifying the resistor R1099 and to introduce the capacitor C1207 on the TX/RX module.

Locate the resistor R1099 (820R) and the tunable inductivity L1026 on the TX/RX Module.

Repair: Replacing the Resistor R1099/820R by a Resistor R1099/150R:

- Use an adequate solder tip to unsolder the 820R Resistor.
- Clean the soldering pads.
- Take the supplied NEW Resistor R1099, 150R, and position it.
- Use an adequate solder tip and solder.
