29.07.2010

SERVICE BULLETIN SB FSG2T-1.06

TYPE DESIGNATION FSG 2T VHF/AM Airband Transceiver – Part number F10350

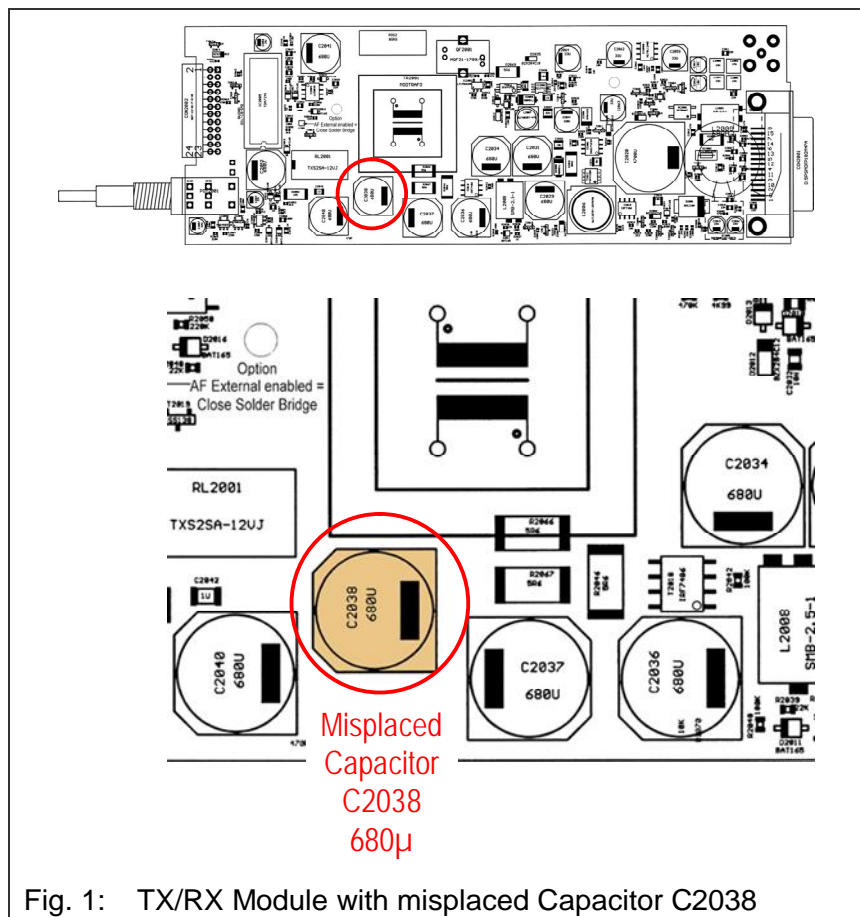
REASON Possible degradation of operational availability could create disruption of VHF communication due to internal capacitor misplacement. The capacitor could be destroyed and could be separated with possible generation of smoke.

Locate the misplaced capacitor C2038 (680 μ) on the TX/RX Module.

Fig. 1: TX/RX Module with misplaced Capacitor C2038

DESCRIPTION Replace the misplaced capacitor by a new capacitor placed as shown in the attachment. To have access to the capacitor it is necessary to open the unit and to separate the TX/RX Module from the Chassis. Remove the adhesive fixing and replace the SMD capacitor.

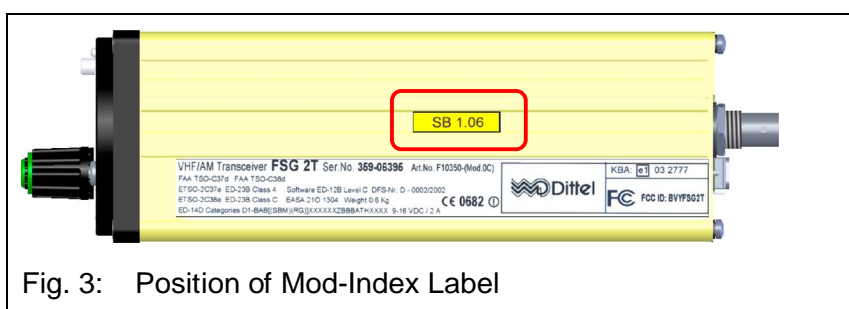
Fig. 3: Position of Mod-Index Label

After meeting the required minimum performance values mark the transceiver FSG 2T with the supplied Mod-Index label
